HAZARD ANALYSIS OF BARAGA CLIFFS

GE 3860: Engineering Geology & Geoinformatics

Prepared by
NIMISHA VERMA

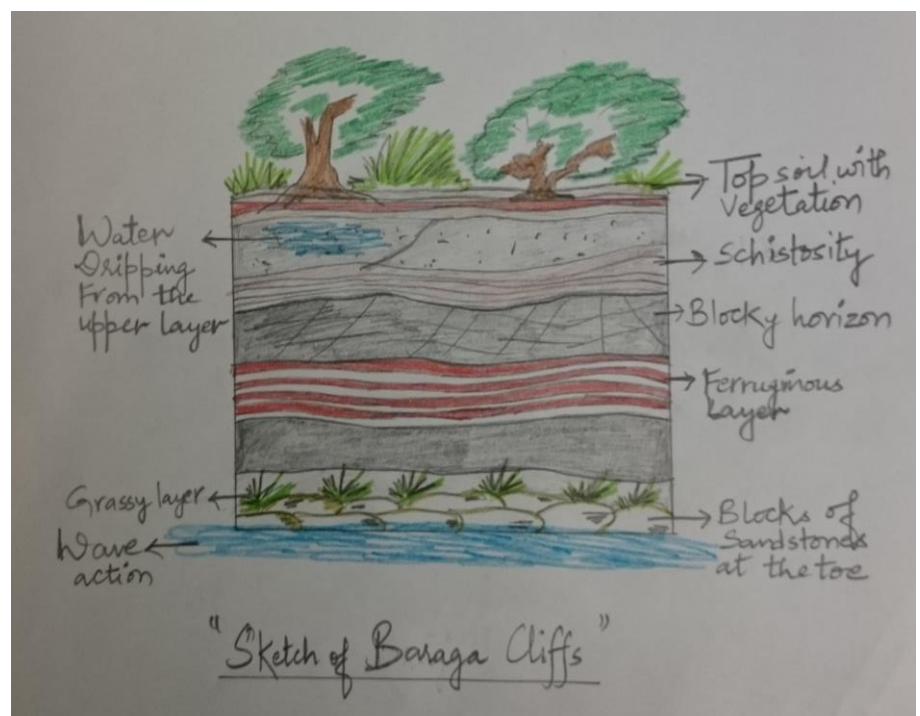
FIGURE 2 SKETCH OF BARAGA CLIFF

The strata of the cliff was studied insitu by using visual techniques that resulted in a schematic cross section which is seen in the figure on the right.

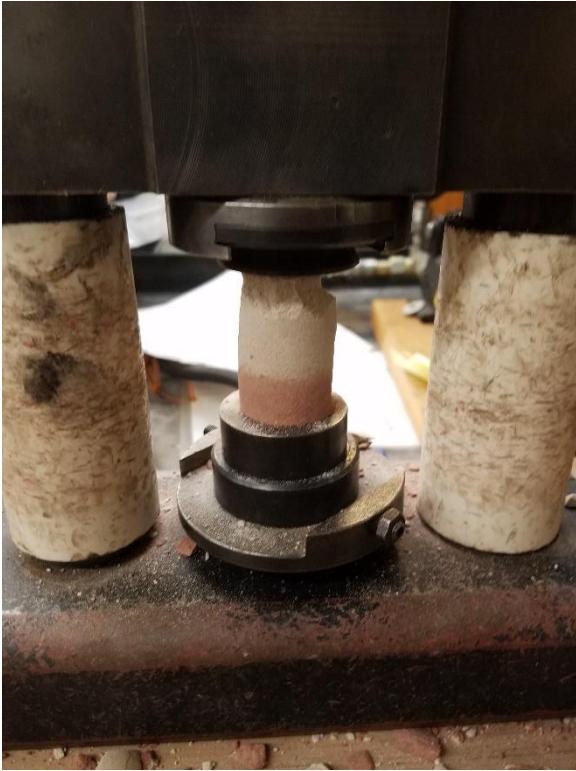
FIGURE 9 CORE SAMPLE UNDER UCS TEST MACHINE

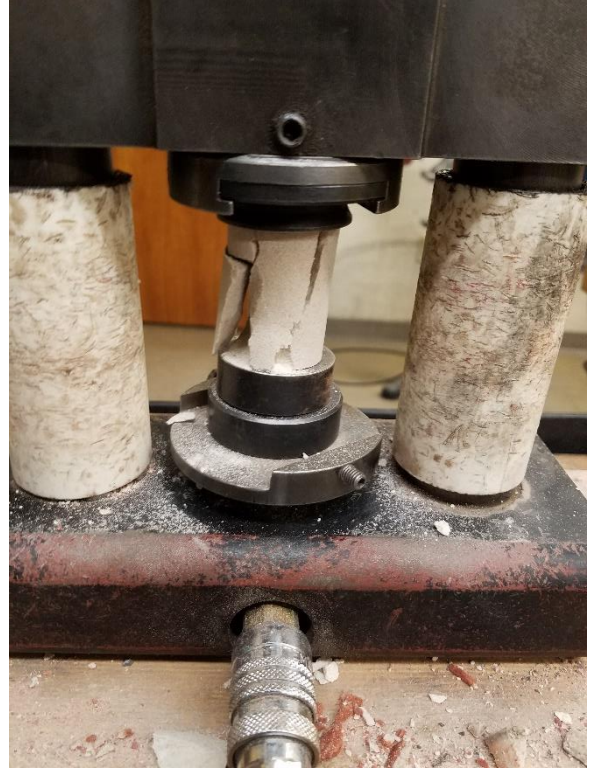
45° fracture plane observed under the machine o the sample failure that can be illustrated by the figures below:

FIGURE 10 PERFECT 45 DEG FRACTURE PLANE

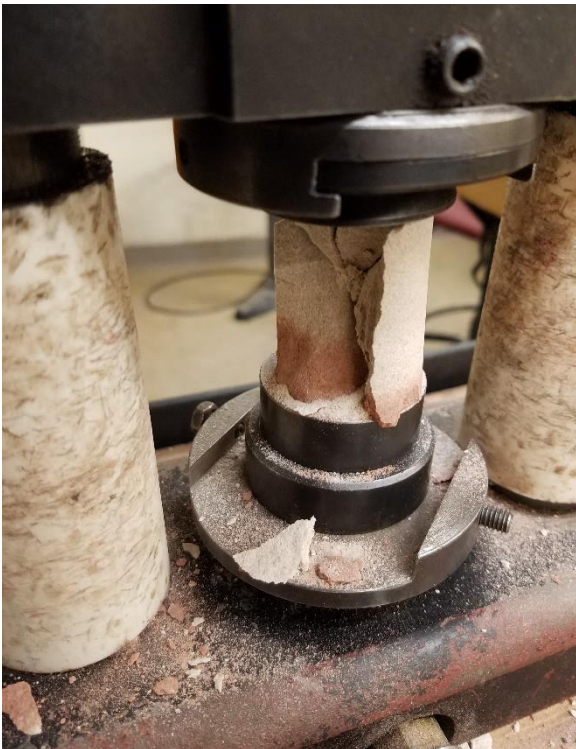
FIGURE 11 FRACTURED SAMPLE

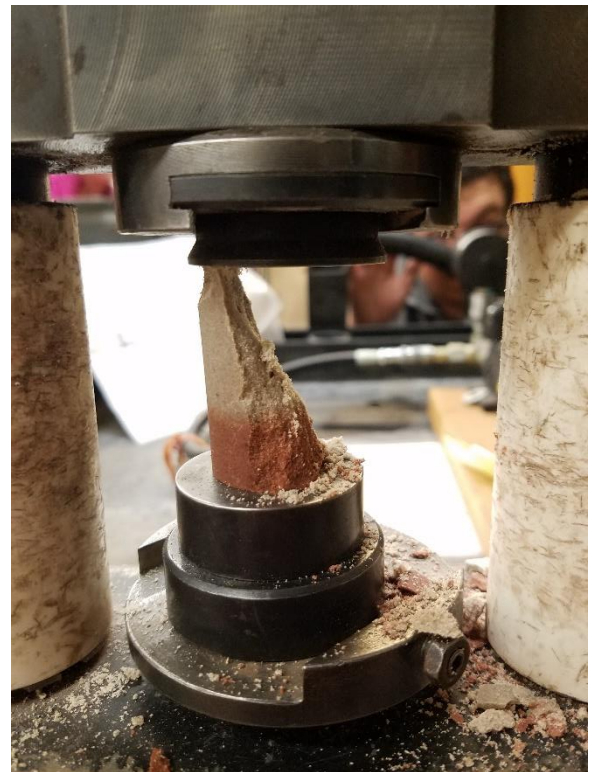
FIGURE 12 FRACTURED SAMPLE
