HAZARD ANALYSIS OF BARAGA CLIFFS

GE 3860: Engineering Geology & Geoinformatics

Prepared by
NIMISHA VERMA

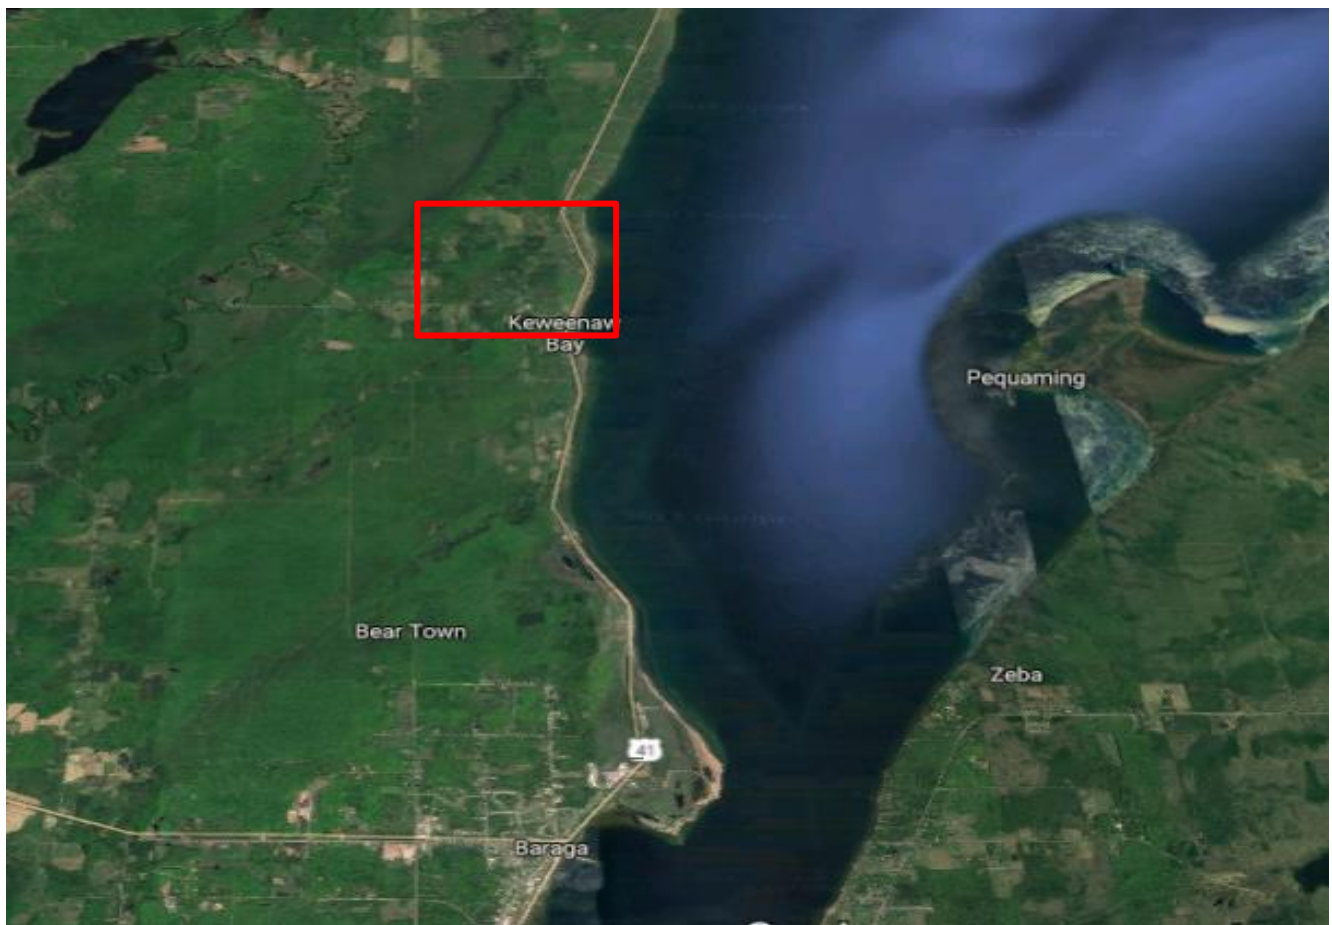
FIGURE 1 LOCATION OF SECTION OF HIGHWAY US-41

The highlighted area in red polygon is our area of interest that marks the region deteriorating due to natural phenomena as well as human activities.
